Nelson City Council

2008 Crash Reduction Study

Traffic Design Group

April 2009

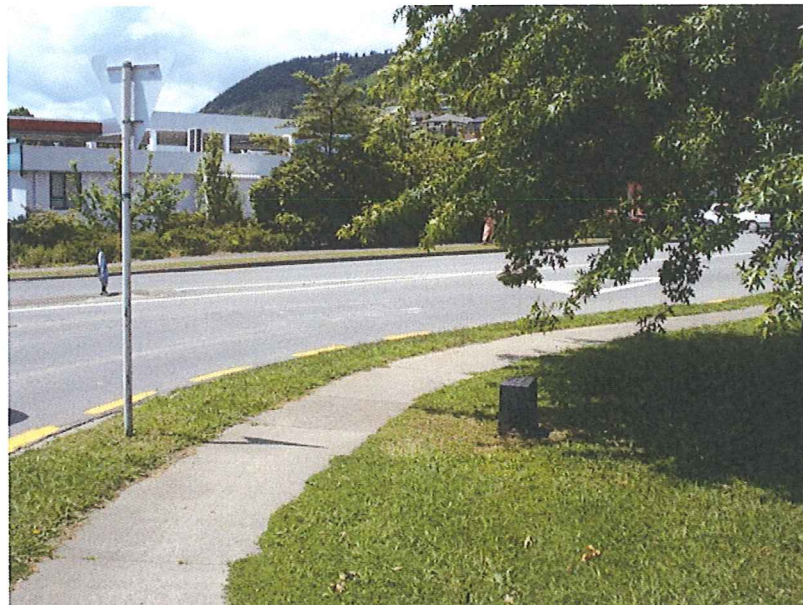
- there are a high number of crossing/turning crashes, particularly involving cyclists, principally at the Market Road intersection
- 46% of the reported crashes involved failure to give way
- during on-site observations, the study team concluded that the general complexity of the staggered tee intersection layout within a very high trafficked corridor and the large number of conflicting movements was the major factor contributing factor to the high number of crashes at this location.

Photograph 1 : Looking west on Boundary Road showing vegetation obscuring signage

*Option 1* : Minor improvements to signage, road markings and inter-visibility of the intersection by:

1. re-marking all existing road markings with waterborne paints containing 'Visi' beads<sup>1</sup>
2. re-painting (using the same grade paint as above) at least the noses of each of the traffic islands to ensure night time conspicuity of the islands
3. improving the intersection lighting to meet AS/NZS1158: Street Lighting standards
4. trimming back the trees in the reserve on the southeast corner of the Waimea/Market intersection to ensure the give way sign is visible
5. marking a green cycle lane with cycle symbol across the intersection with Market Road

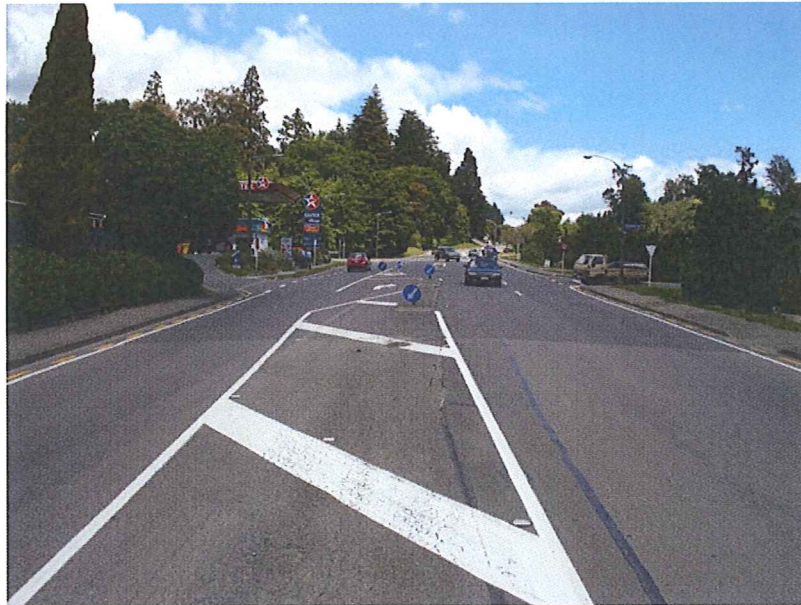
**Photograph 2 : Looking south showing complexity of intersection layout with poorly delineated islands**

*Option 2* : Simplify intersection arrangement by minimising turning movement conflicts, ie:

1. close the Boundary Road approach and creating a cul-de-sac. This will require that the recommended signalling of the Waimea Road/Motueka Street intersection be adopted in order to provide safe and convenient access to Waimea Road for existing right-turners from Boundary Road
2. as a result of the above changes there is surplus space within the intersection to create a flush median separating the left turn lane into Market Road from the through traffic and in doing so increasing visibility for vehicles turning out of Market Road
3. shift the start of the passing lane to the south of Market Road so right-turners from Market Road only need to cross one lane of traffic
4. improve road markings, signage and street lighting.

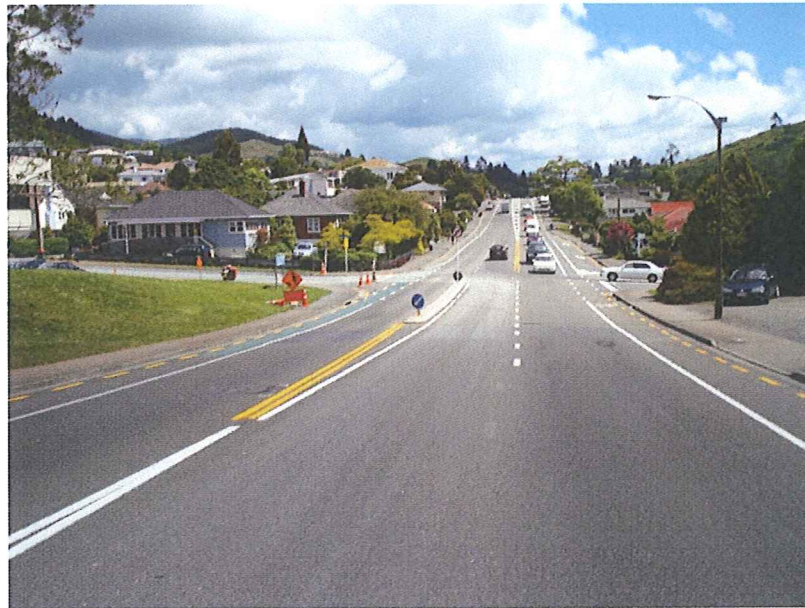
**Photograph 3 : Looking south on Waimea Road showing vehicle waiting to turn right from Motueka Street and one vehicle having just completed movement**

- 55% of reported crashes involved a vehicle turning right into Waimea Road, from the western approach of Motueka Street, failing to give way to a northbound through vehicle. This may be exacerbated by the separate left-turn lane, in which left-turning vehicles can obscure through vehicles to motorists waiting on the Motueka Street west approach
- the investigation team were unanimous in their conclusion that there was no 'low cost' solution available that would address the existing safety issue.

1. establish a signalised seagull control at the intersection to improve right-turn facilities. This allows the southbound vehicles unimpeded flow through the intersection but stops the northbound through vehicles for short periods to allow right turning vehicles access from the western Motueka Street approach
2. limit access to and from the eastern leg of Motueka Street to 'left-in, left-out' vehicle movements only, to allow the signals to operate in a suitably efficient manner and limit delays to northbound through vehicles on Waimea Road
3. paint the northbound cycle lane for the length that it conflicts with left-turn vehicles crossing into the left-turn lane.

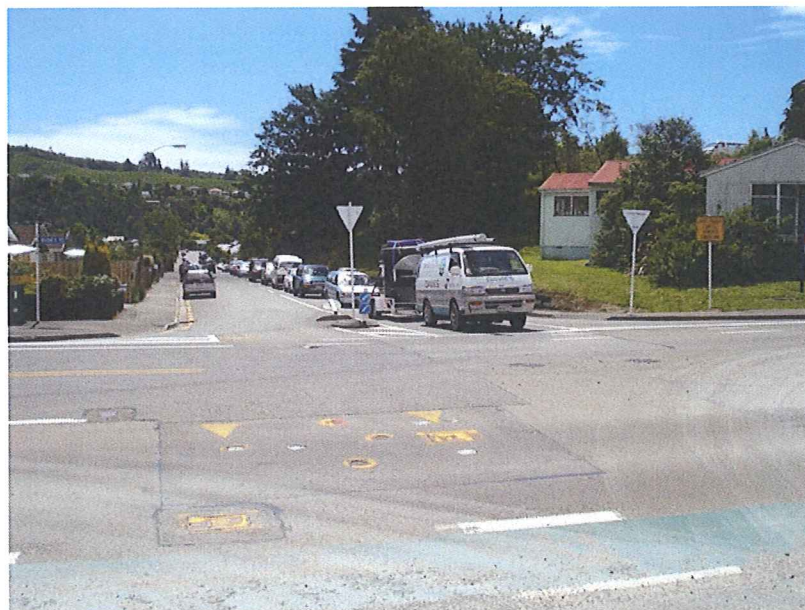
**Photograph 4 : Looking west on Motueka Street showing queued vehicles and difficult starting conditions with vertical grade**

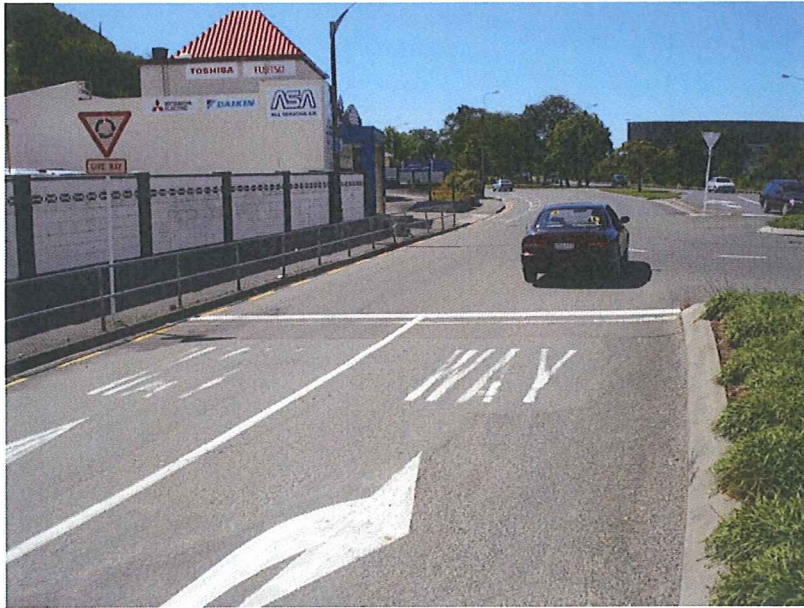
- the majority of the crashes recorded at the site were attributed to drivers failing to give way at the intersection. Approaching vehicle speeds were observed to be high through the intersection. This is due to the poor deflection provided by the small centre island and alignment of the approach lanes
- a total of five crashes involving cyclists were also recorded, with the majority of these approaching the intersection from the north on Haven Road.

Photograph 5 : Looking north on Haven Road showing poor deflection for through traffic on this approach

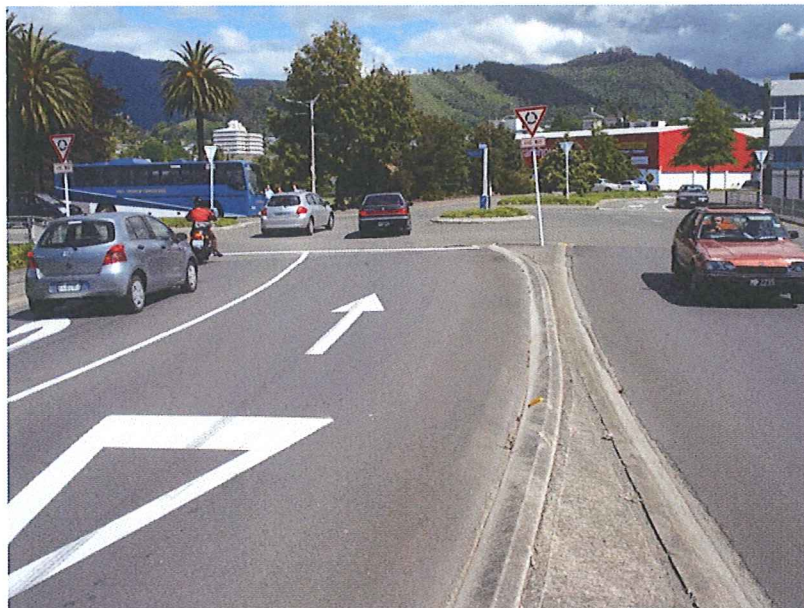
Photograph 6 : Looking south on Haven Road showing poor deflection for through traffic on this approach

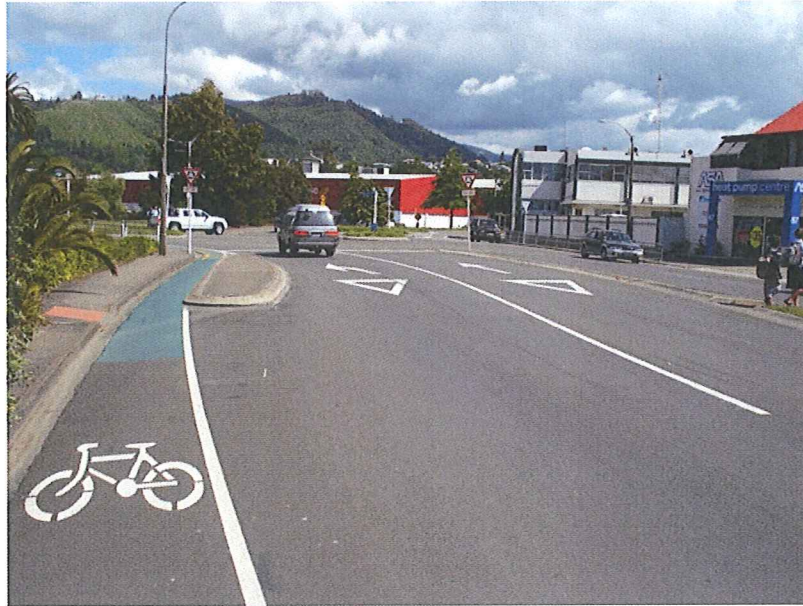
Photograph 7 : Looking south on Haven Road showing cycle path hidden from left turning vehicles

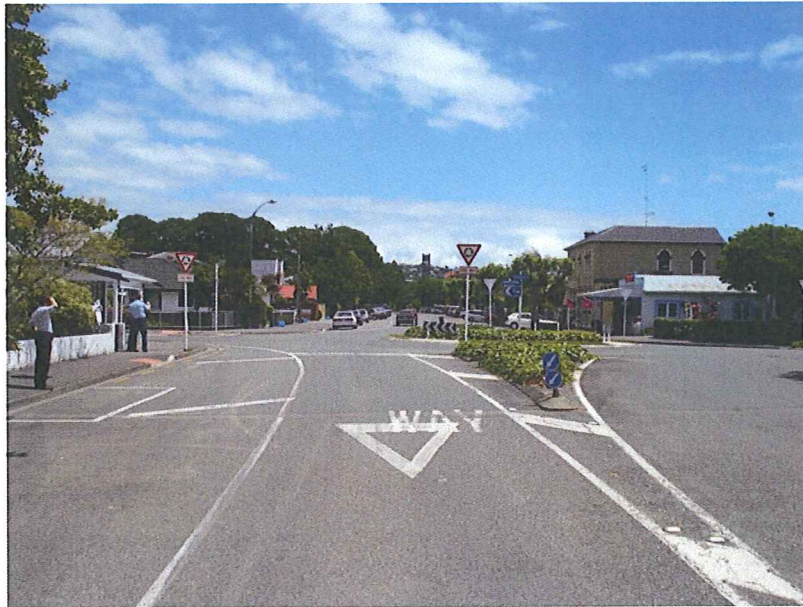
- General observations on-site showed that speeds through the intersection were high for this type of intersection control. Specifically, vehicles travelling straight through the intersection travelling either east to west or west to east on Nile Street were not slowing adequately. The primary cause of this excess speed is caused by the minimal deflection and geometric layout of the roundabout control.

**Photograph 8 : Looking west on Nile Street showing poor deflection for through traffic. The photo also shows the lack of islands on the left side of the lane that would assist in channelizing the traffic. This is typical of the whole intersection**

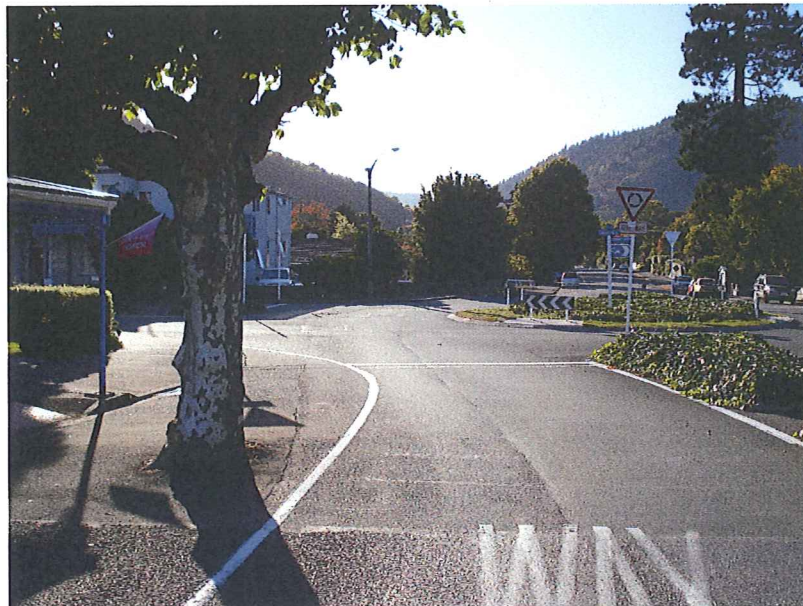
**Photograph 9 : Tree Close to Edgeline on Roundabout Approach**
